Snap-Lug, Quick Disconnect Power Connector

Testing was performed on the TE Connectivity Snap-Lug, Quick Disconnect Power Connector, to determine its conformance to the requirements of Product Specification 108-32083, Rev A.

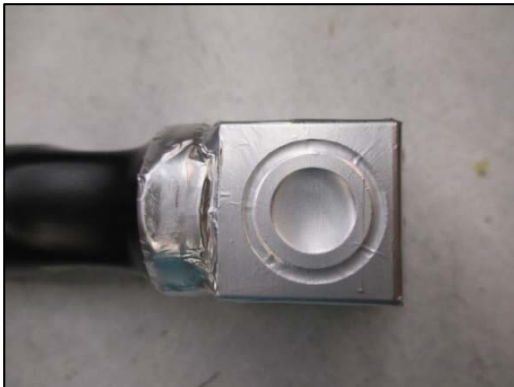
Figure 2 – DWV Sample Prep

Dielectric withstanding voltage testing was conducted in accordance with EIA-364-20E. Specimens were prepared by wrapping the entire surface of the housing in conductive foil (Figure 2). A test potential of 1500 volts AC was applied between the socket contact and the foil (Figure 3). The voltage was applied at a rate of 500 volts per second. This potential was applied for one minute and then returned to zero.

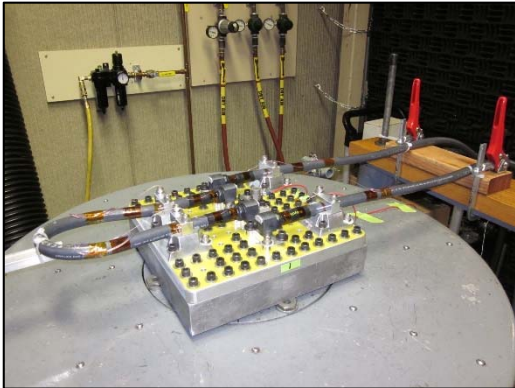
Random vibration was conducted in accordance with MIL-STD-810G, Method 514.7. The parameters of this test condition are specified by a random vibration spectrum with excitation frequency bounds of 20 and 500 Hertz (Hz). The power spectral density (PSD) is flat at $0.04 \text{ G}^2/\text{Hz}$ from 20 Hz to the upper bound frequency of 500 Hz. The root-mean square amplitude of the excitation was 4.5 GRMS. The test specimens were subjected to this test for 1 hour in each of the three mutually perpendicular axes, for a total test time of 3 hours per test specimen. The test specimens were monitored for discontinuities of 1 microsecond or greater using an energizing current of 100 milliamperes.

Figure 4 – Vibration, TG1, Vertical Axis

Figure 5 – Vibration, TG1, Transverse Axis

Figure 6 – Vibration, TG1, Longitudinal Axis

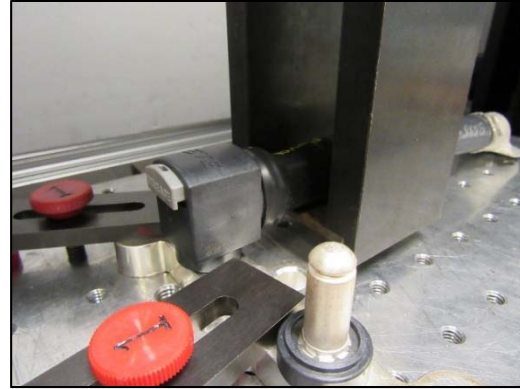
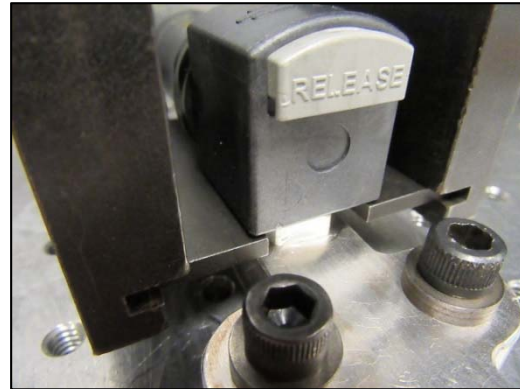
Connector pull testing was conducted in accordance with Product Specification 108-32083, Rev A. Specimens were mounted to the tensile/compression machine in each of three configurations (Figure 14 through 20). A force of 125 pounds was applied at 0.5 inches per minute. Upon completion of testing specimens were evaluated for damage.

Figure 15 – Horizontal Pull

Figure 16 – Horizontal Pull

Figure 17 – Vertical Push

Figure 18 – Vertical Push

Figure 19 – Vertical Pull

Figure 20 – Vertical Pull

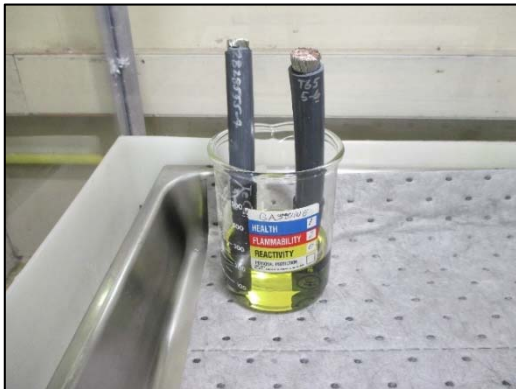
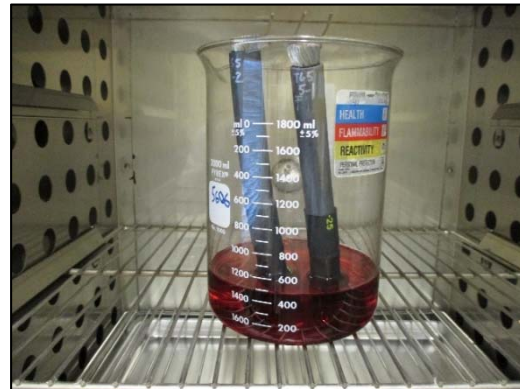
Figure 22 – Typical Fluid Immersion Setup

Fluid Immersion was conducted in accordance with EIA-364-10F. See Table 4 for testing fluids and exposure parameters.

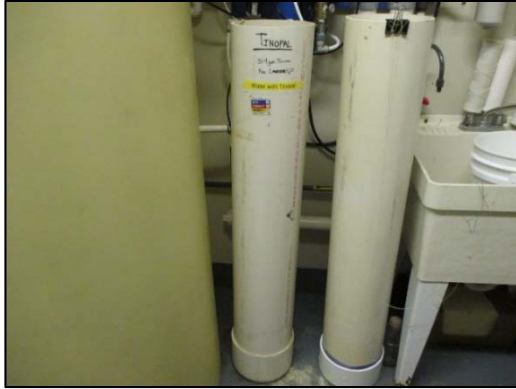
Figure 24 – 1m Test Vessel

Water immersion testing was conducted in accordance with paragraph 14.2.7 of IEC 60529, Edition 2.2, 2013-08. Specimens were subjected to immersion testing in water containing a ultra-violet tracer at a depth of 1m for 30 minutes. Upon completion of testing, specimens were dried at an elevated temperature of 38°C for approximately 24 hours. Once dry, the specimens were unmated and evaluated with an ultra-violet light (UV-A) for signs of water ingress.

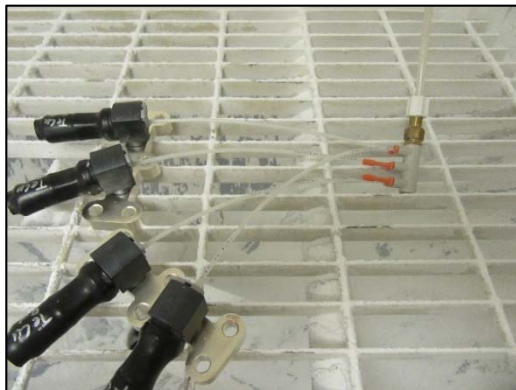
Figure 26 – Specimens in Dust Chamber

Dust testing was conducted in accordance with paragraph 14.2.7 of IEC 60529, Edition 2.2, 2013-08. Specimens were placed in the talcum dust chamber. The pressure inside the connector was subjected to depression of 2 kPa maximum. Specimens were subjected to dust exposure for 8 hours. Upon completion of testing specimens were unmated and examined for dust ingress. Specimens were also examined to ensure the latching and release mechanisms functioned properly.
