SRC - Sealed Rectangular Connector

Product qualification testing of SRC connector system as per TEC-108-160018.

This report covers the electrical and environmental performance of the Sealed Rectangular Connector (SRC) system.

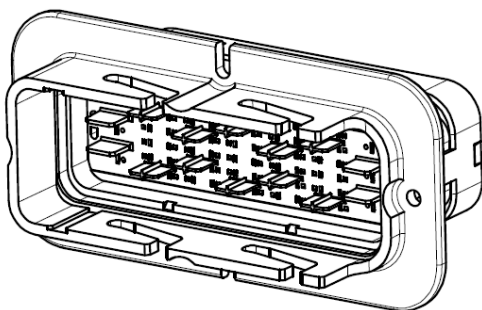
Figure 1: SRC 60+6 Mixed Power Blade Assembly Housing Mating Interface

The Sealed Rectangular Connector (SRC) is designed to meet the need for a rugged, environmentally sealed connector system supporting power and low-level signal applications. The system is comprised of a wire-to-wire configuration and is based upon the MX150L and MX150 blade and receptacle type terminals. The design features all-in-one plug and receptacle housings with pre-assembled wire and interfacial seals with a Terminal Position Assurance (TPA) component to aid assembly.

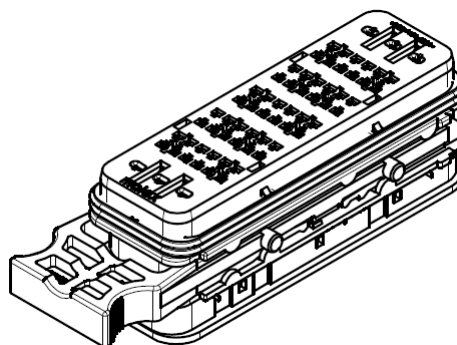
Figure 2: SRC 60+6 Mixed Power Female Receptacle Assembly Housing Mating Interface

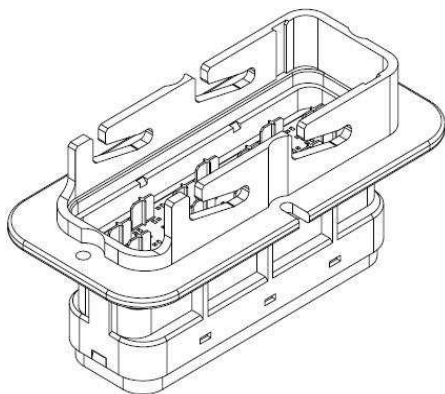
Figure 3: SRC 84 Pin Mixed Power Female Receptacle Housing Mating Interface

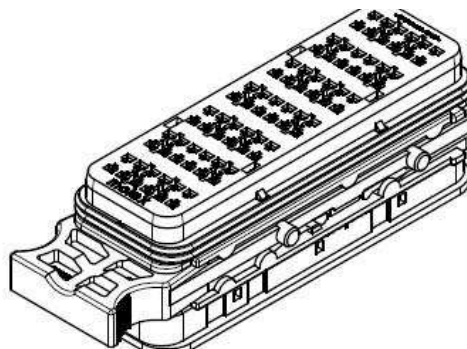
Figure 4: SRC Female 84 Pin Receptacle Housing Assembly

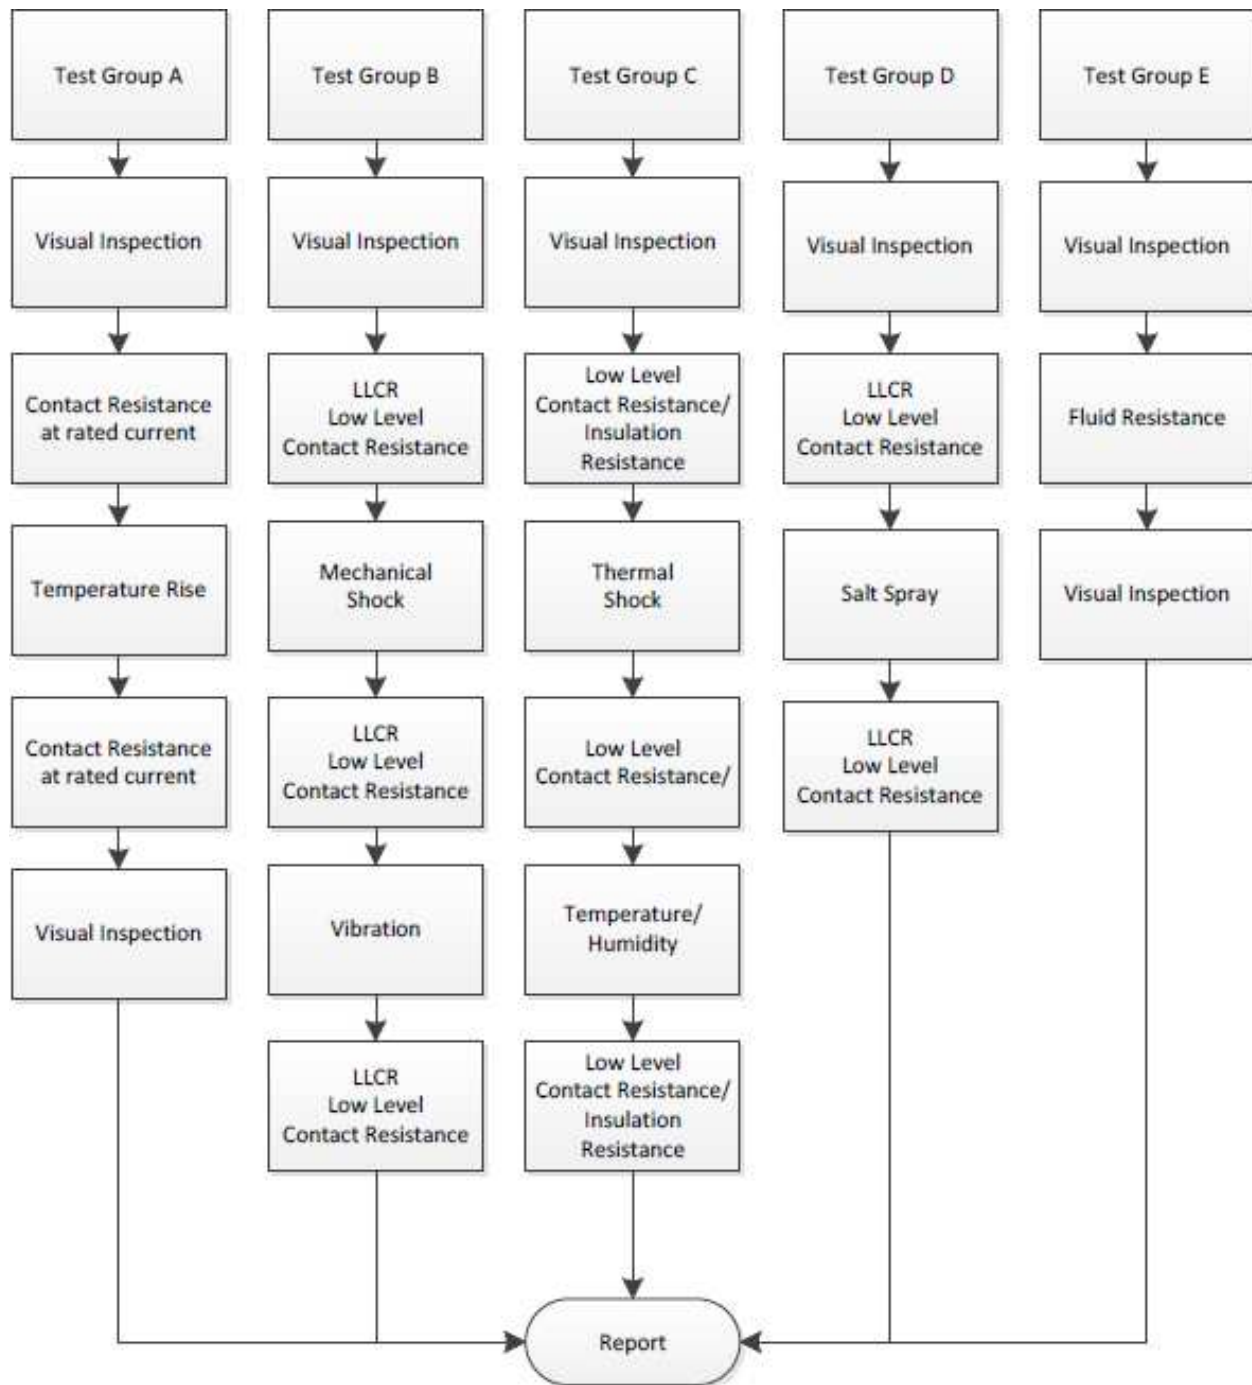
Figure 5: Test Sequence Part 1 of 2

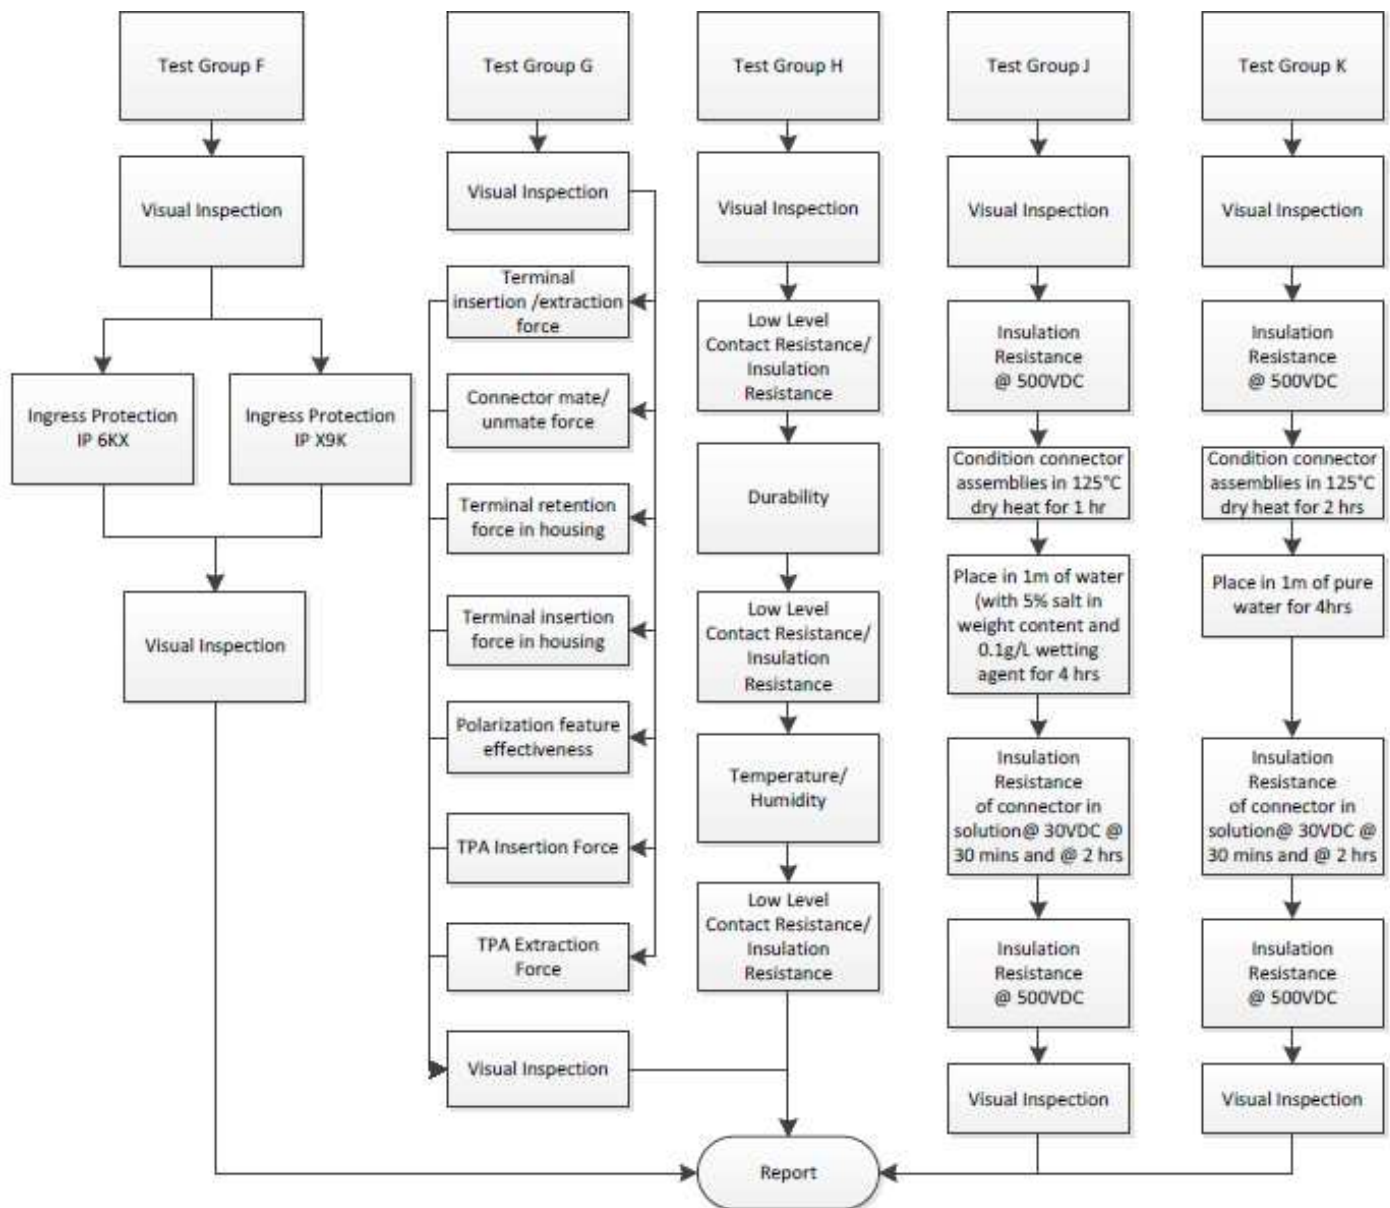
Figure 6: Test Sequence Part 2 of 2

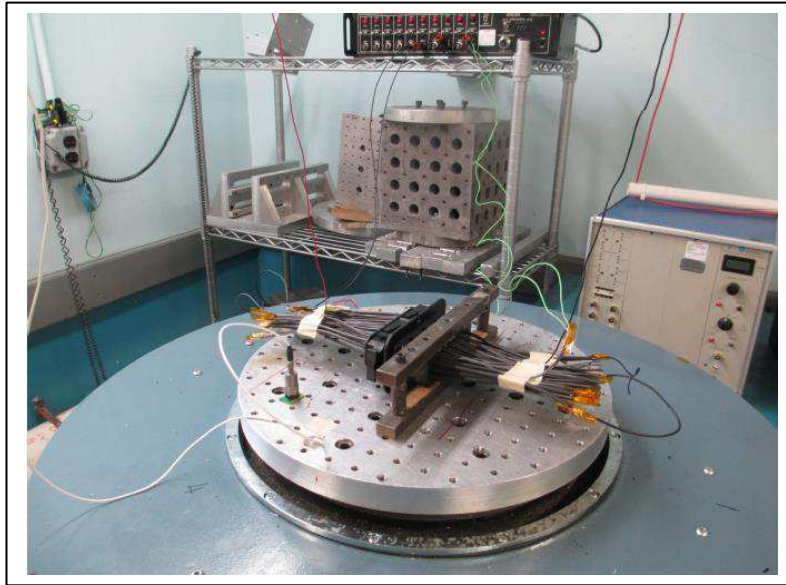
Figure 7: Test Group B : Contech Research Inc.: Mechanical Shock/Vibration Typical Test Setup

5.3.13	Mechanical Shock	10 mΩ MAXIMUM (change from initial contact resistance)	Delta [mΩ]	Delta [mΩ]	Delta [mΩ]	
		Signal MX150	1.6	0.2	-1.1	Pass
		Power MX150L	1.4	-1.3	-5.7	Pass
		No Discontinuity > 1ms with a current of 100 mA	No Discontinuity > 1ms with a current of 100 mA			Pass

5.3.14	Vibration	10 mΩ MAXIMUM (change from initial contact resistance)	Delta [mΩ]	Delta [mΩ]	Delta [mΩ]	
		Signal MX150	0.7	-0.3	-3.3	Pass
		Power MX150L	0.3	-3.0	-8.4	Pass
		No Discontinuity > 1ms with a current of 100 mA	No Discontinuity > 1ms with a current of 100 mA			Pass

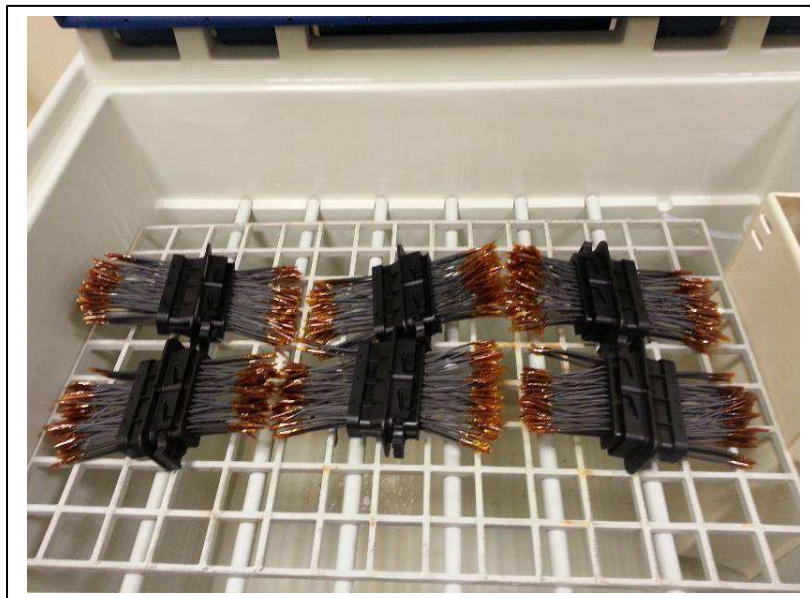
Figure 8: Test Group D : Setup of Samples in Salt Spray chamber

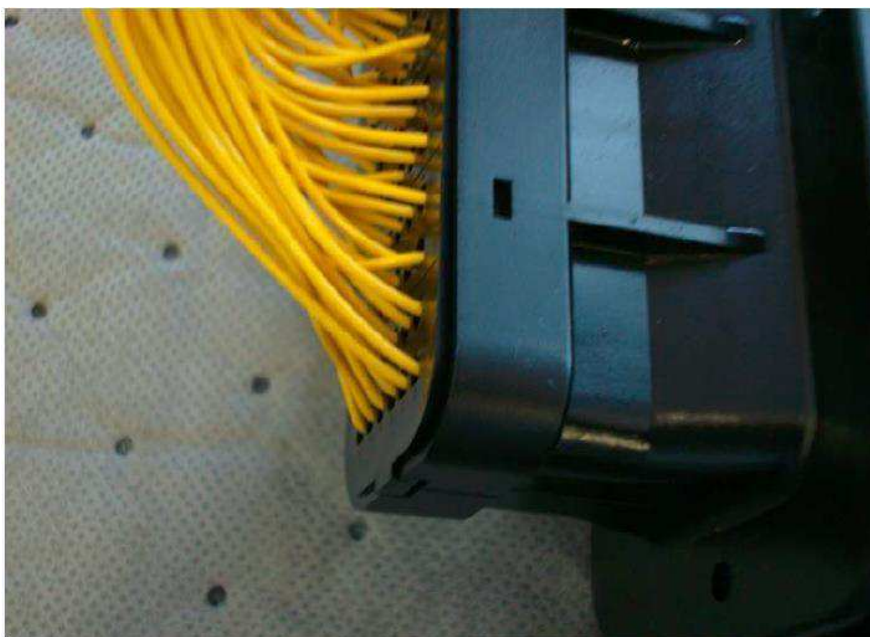
Figure 9: Observation that lifting of the edge of the rear cover feature from the female housing part occurred. This was due to diesel impregnating the seal

* The following observation was noted that during the Fluid Immersion Test for diesel that lifting of the edge of the rear cover feature from the female housing occurred. This was due to diesel impregnating the seal.

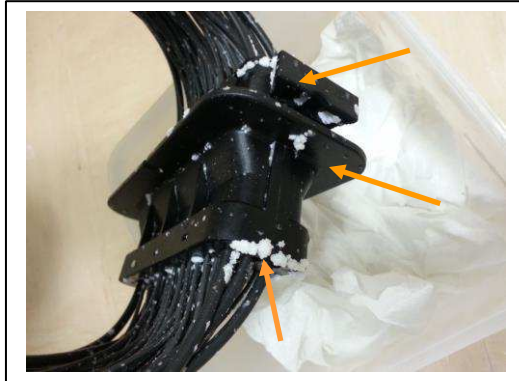
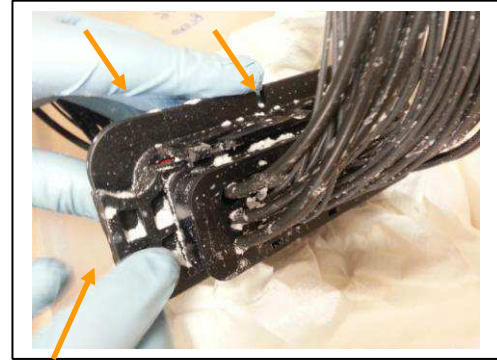
Figure 10: Fluid Resistance test: ADBLUE, formation of Urea crystals on part as water evaporates from ADBLUE solution during 24 Hour air dry cycles.

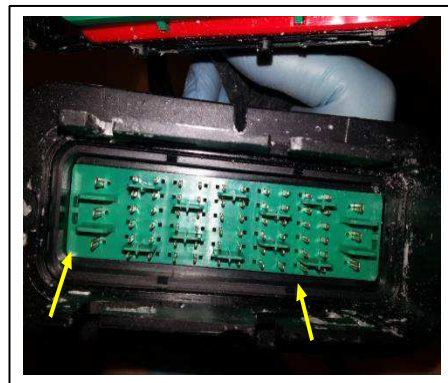
Figure 11: No Urea crystals on mating surface of part

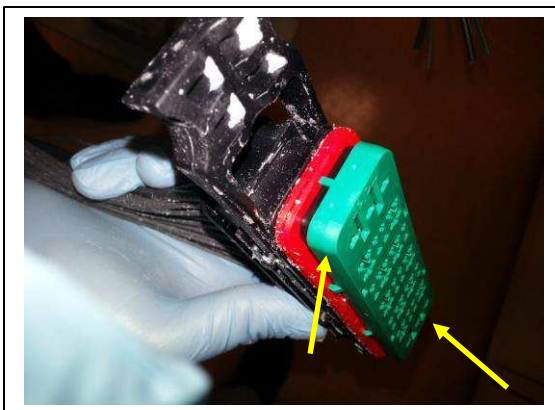
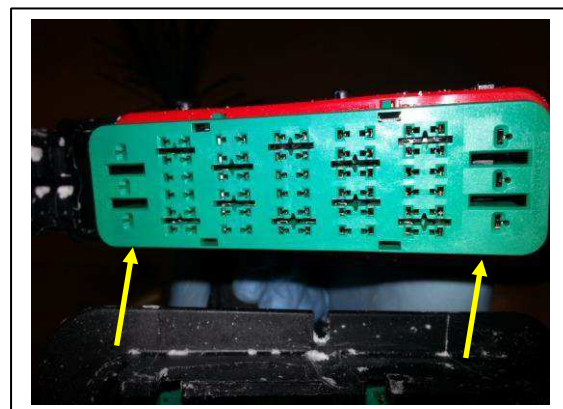
Figure 12: No Urea crystals on mating surface of part

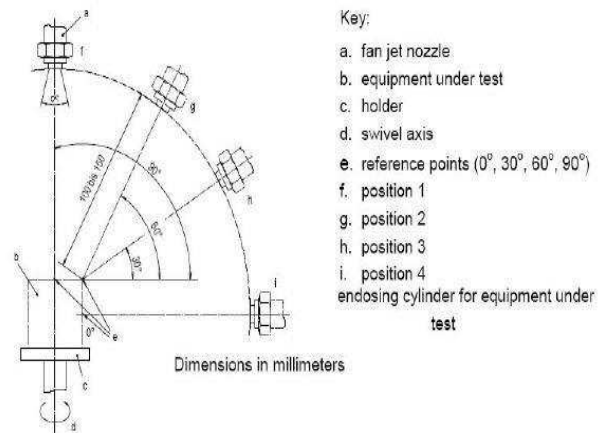
Figure 13: : IPX9K Test setup for determining protection against high pressure/steam jet cleaning

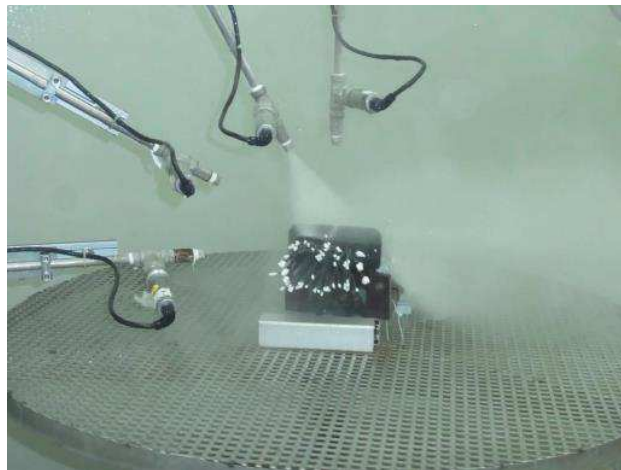
Figure 14: specimen during the steam jet test (30° angle)

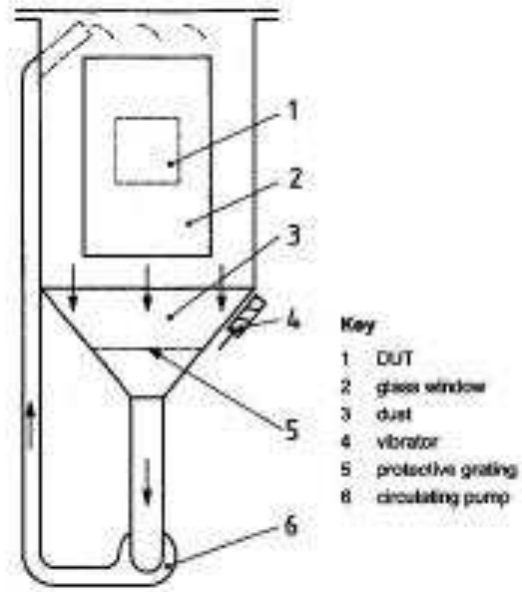
Figure 15: Test set-up for IP6KX (example of a dust chamber with vertical flow of the air/dust mixture)

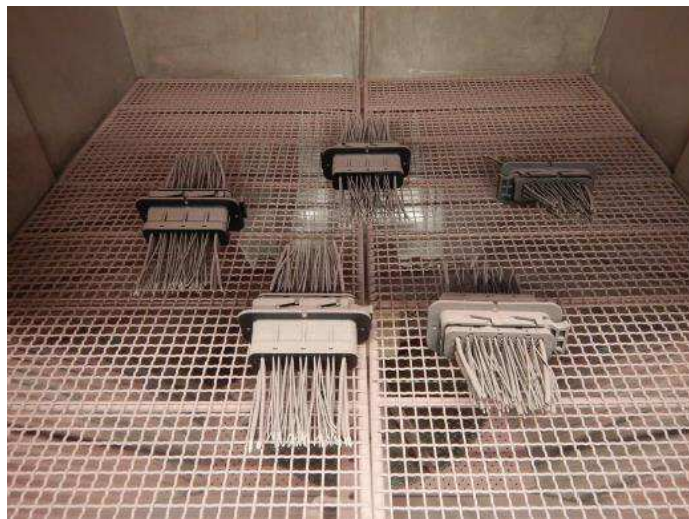
Figure 16: Specimens in the dust test chamber for IP6KX (after test)

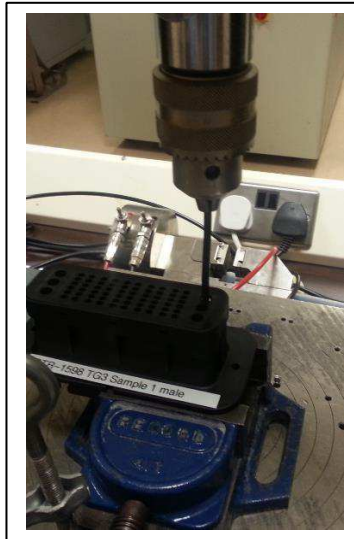
Figure 17: Setup of Zwick/Roell force tester for male terminal insertion into male housing

5.3.9	Terminal Insertion Force Into Housing	30N Maximum Male Power MX150L terminals into male housing	[N] 19.10	[N] 14.09	[N] 10.90	Pass
		Female Power MX150L terminal into Female housings	23.50	14.19	9.67	Pass

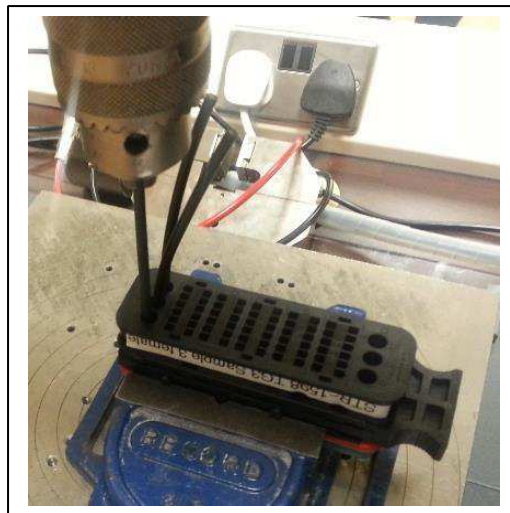
Figure 18: Setup of Zwick/Roell force tester for female terminal insertion into female housing

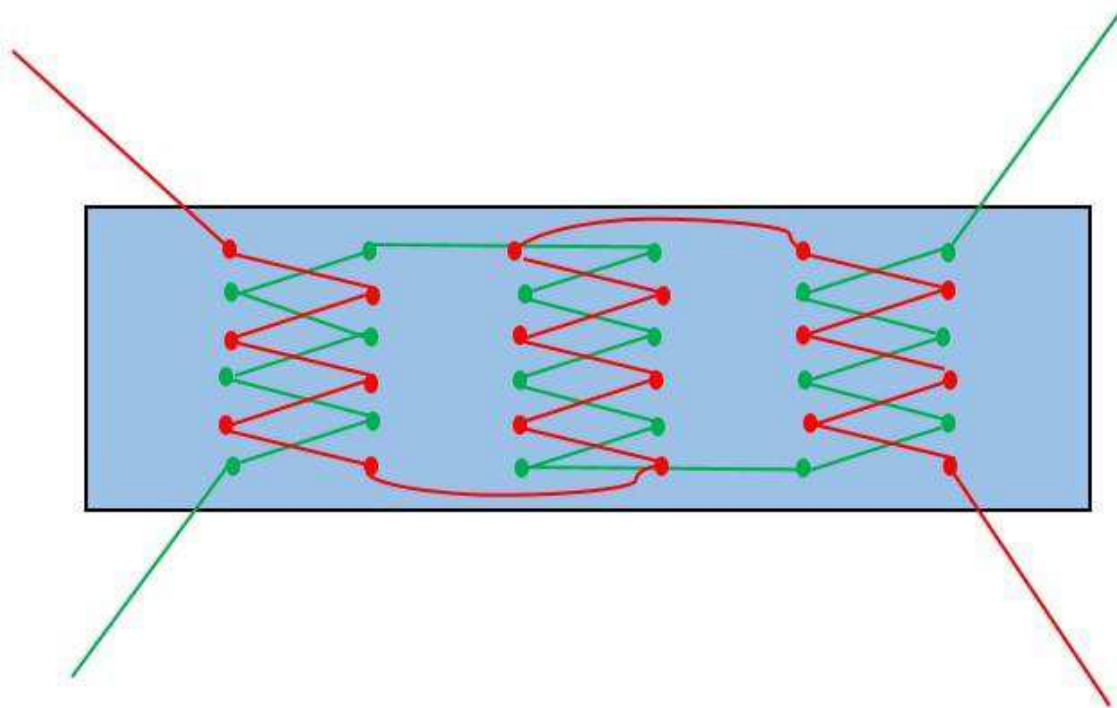
Figure 19: demonstrates the wiring diagram used to bus the connector harness

Harnesses were bussed in this way so that all terminals were wired opposite to its neighboring terminals,
 Note: only 3 pockets are shown in the wiring diagram as the diagram repeats itself across the connector

All connector samples that underwent immersion test were bussed so that all adjacent cables could be tested at once to reduce testing time between individual adjacent terminals (see Figure 26).

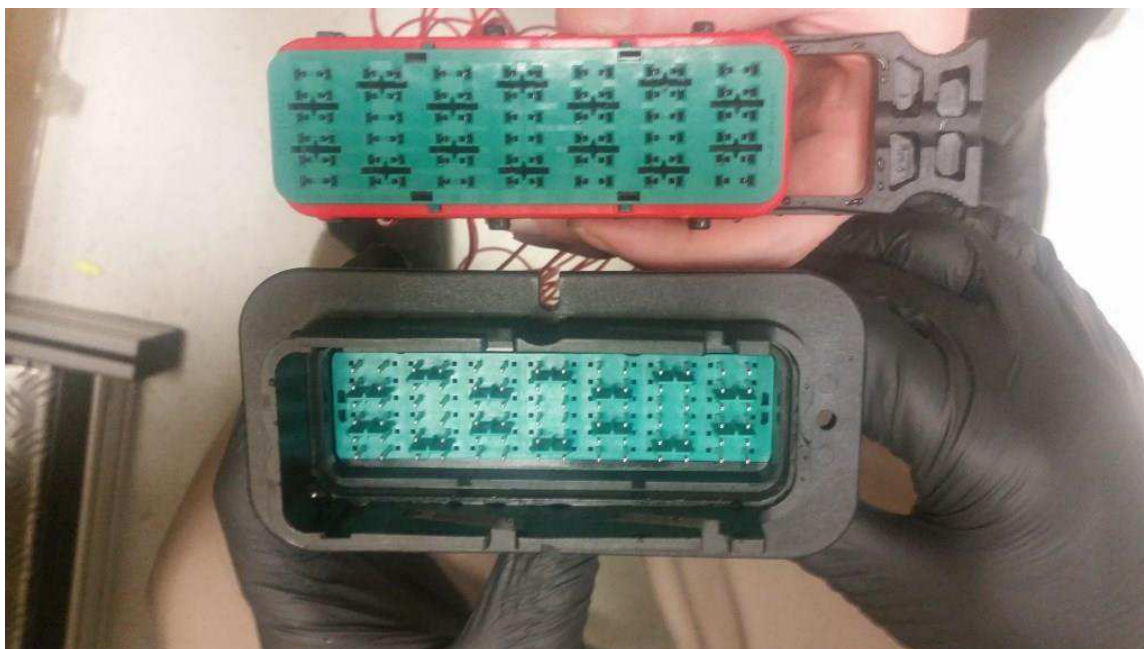
Figure 20: Visual Inspection Post Insulation Resistance/Immersion Test, No ingress of solution
