DETECTING AND MONITORING CORROSION UNDER INSULATION IN THE OIL AND GAS INDUSTRY: THE ROLE OF SENSORS

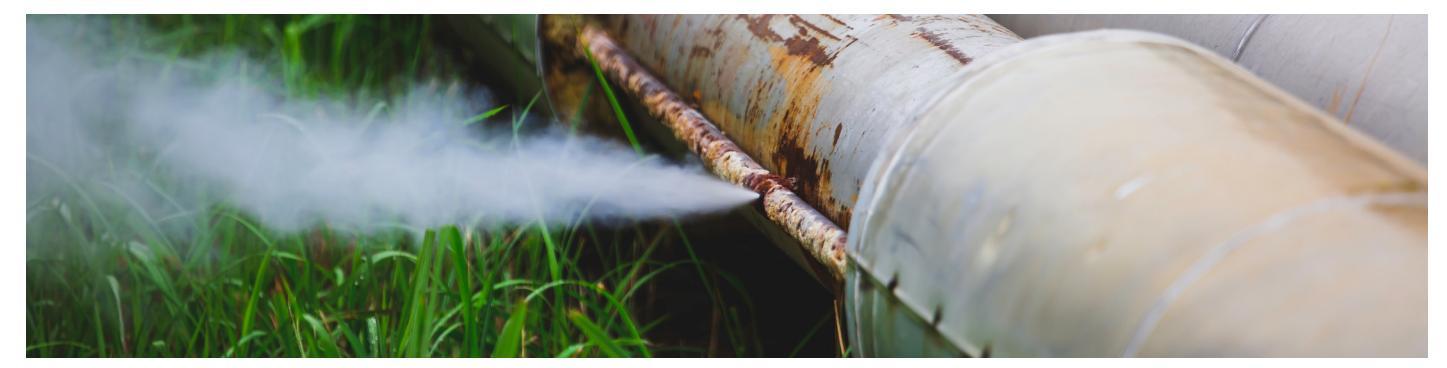
Fig. 1: Corrosive environmental conditions affecting an insulated pipe.

Firstly, environmental conditions greatly influence the onset of CUI. Humidity, temperature fluctuations, and exposure to salt spray or industrial pollutants can increase the likelihood of water intrusion into the insulation, a prerequisite for CUI. These conditions, combined with the operating temperature of the equipment, often create the perfect conditions for corrosion.

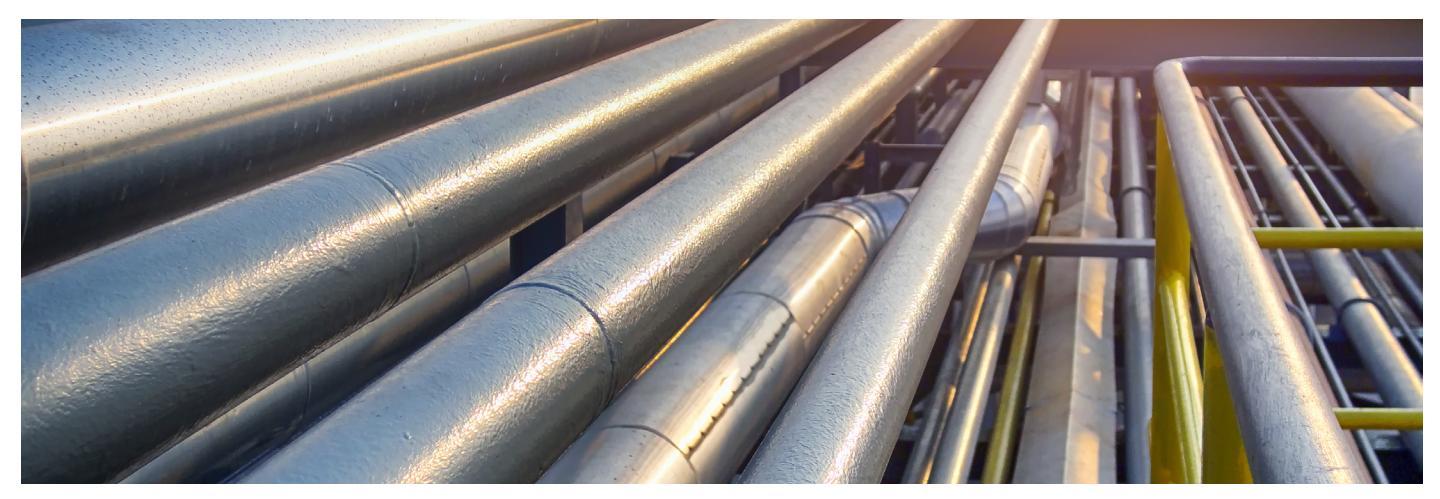
Fig 2: Insulated pipe with metallic cladding.

To physically secure the insulation and protect it from external weather conditions, a metallic jacket, often referred to as "cladding", is affixed around the insulation, held in place with metallic bands. This jacket is designed to wrap around the insulation, resulting in the creation of longitudinal or radial joints.

Water intrusion can occur if the cladding is damaged, seals are broken, or due to external forces such as impacts, sharp or falling objects, or individuals walking on the pipe. Once a water entry point exists, it's not always immediately noticeable, but under rainy conditions, water intrusion becomes inevitable.

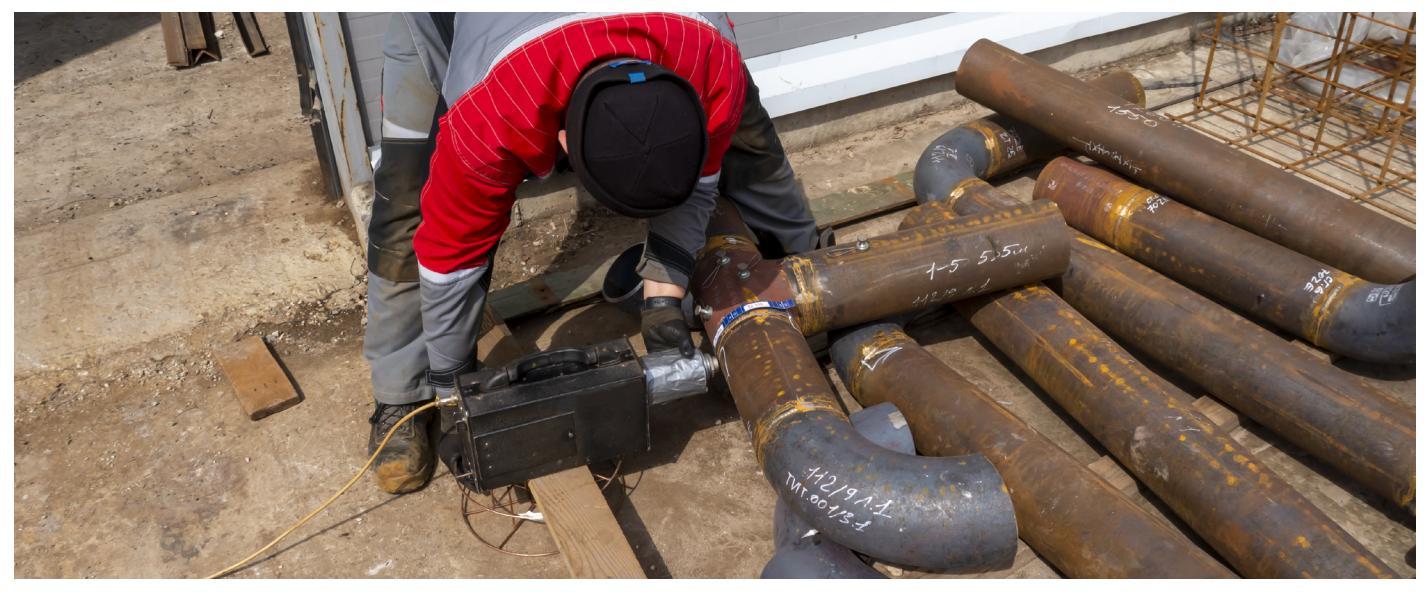
Fig 3. A specialist installing an X-ray device for non-destructive evaluation of welded joints.

- **Real-time Digital Radiography:** X-rays are discharged on one side of the insulated pipe, they go through the pipe, cladding, and insulation, and a sensor will receive the X-ray on the opposite side. The rays received by the sensor are converted into real-time images and will highlight anomalies such as internal or external corrosion or defects on the pipe. This method can be applied without removing the cladding and gives real-time information.

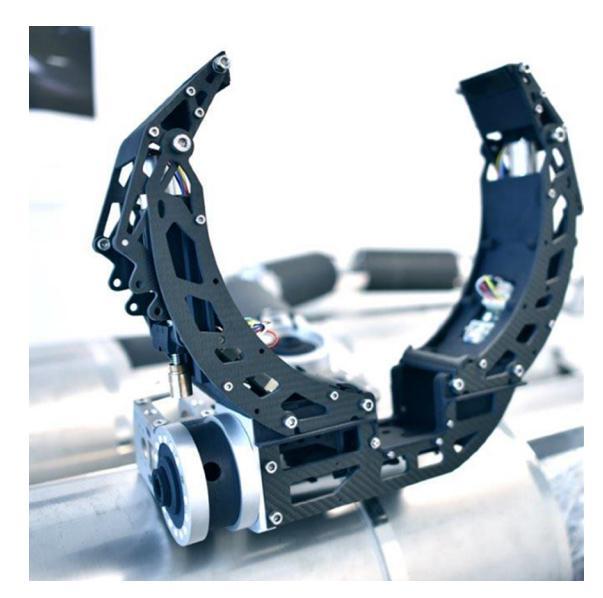
Fig 5: Monkeybot for robotic sensor installation
